Final Research Report

## **Assessing and Understanding Trail Degradation: Results from Big South Fork National River and Recreational Area**

**Jeffrey L. Marion  
Principal Investigator**

**February, 2006**

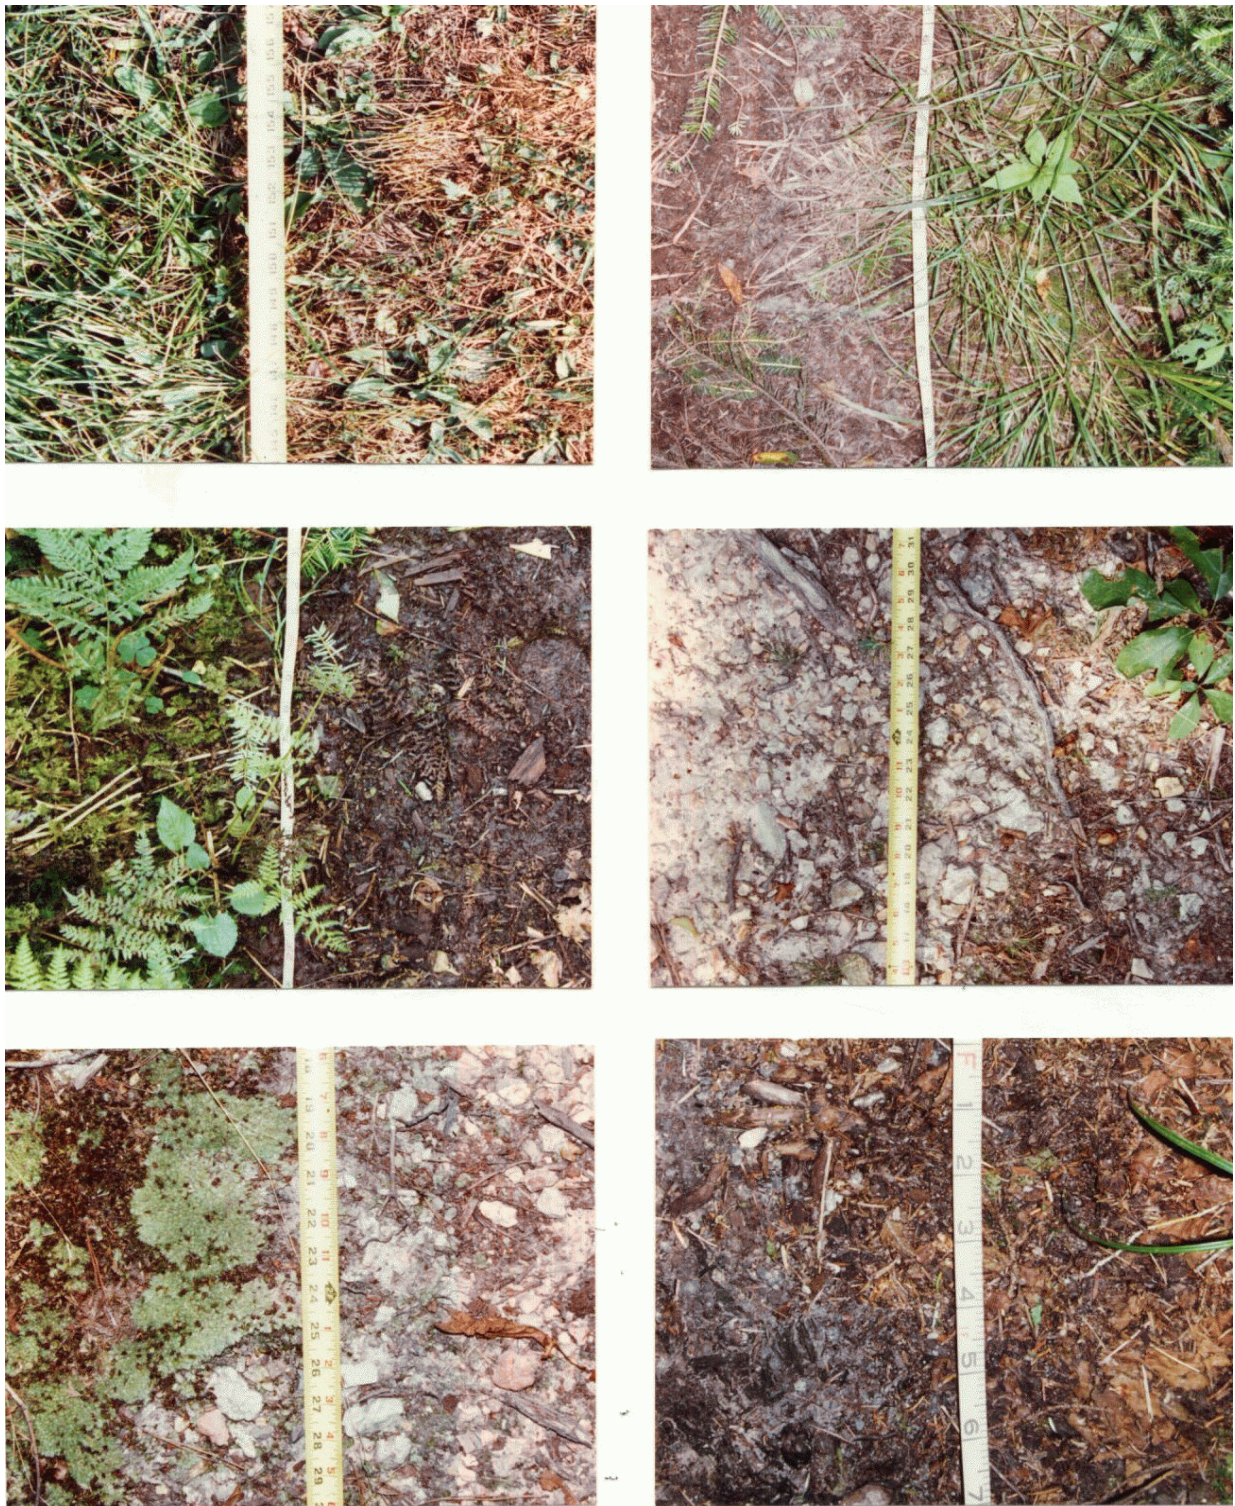
**Figure 1.** Photographs illustrating different types of boundary determinations. Trail tread boundaries are defined as the most pronounced outer boundary of visually obvious human disturbance created by trail use (not trail maintenance like vegetation clearing). These boundaries are defined as pronounced changes in ground vegetation height (trampled vs. untrampled), cover, composition, or, when vegetation cover is reduced or absent, as pronounced changes in organic litter (intact vs. pulverized). The objective is to define the trail tread that receives the majority (>80%) of traffic, selecting the most visually obvious boundary that can be most consistently identified by you and future trail surveyors.
