Research article

Assessing the influence of sustainable trail design and maintenance on soil loss

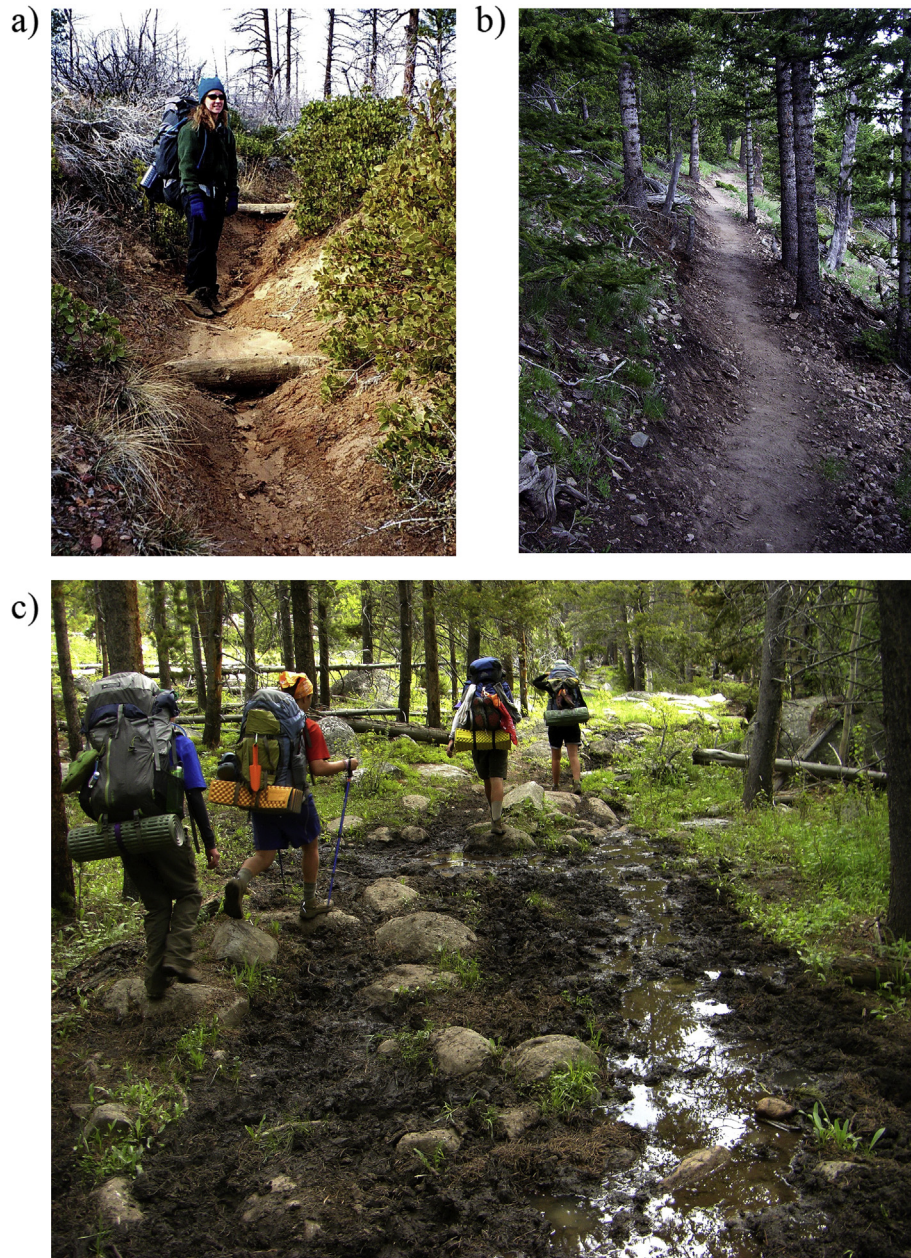
Fig. 2. a) Steep fall-line trails (TSA <22°) erode rapidly. b) Side-hill contour-aligned trails (TSA >69°) resist widening, muddiness, and soil loss. c) TSA is less influential in flat terrain where trail widening and muddiness are common problems. Photos by Jeff Marion.

Regression modeling by Olive and Marion (2009) determined that TSA has “a major and robust influence” on trail soil loss, with fall-aligned trails significantly more susceptible to soil loss. TSA’s influence on soil loss was more significant than trail grade, with regression modeling revealing a diminished but still significant “trail grade” influence after TSA was added to the regression model. Results from statistical modeling of soil loss supported earlier speculation by Leung and Marion (1996) that: “the importance of slope alignment angle increases in its significance as trail grade increases.” The authors also found that horse and ATV use caused significantly greater trail damage by erosion on trails closely aligned to the fall-line than either hiking or mountain biking, with a suggestion to keep horse and ATV trail alignments greater than 48°. In summary, these studies reveal that increasing TSA values contribute to increasing trail sustainability, minimizing soil loss, muddiness, and tread widening. Furthermore, the positive influence of higher TSA values increases with increasing landform grade (less muddiness, trail widening, and soil loss), while the negative influence of lower TSA values increases with increasing trail grade (steeper fall-aligned trails erode more quickly) (Fig. 2).

Proudman, 2000; IMBA, 2004; Parker, 2004) (Fig. 2b). Authors most commonly recommend out-sloping treads to the downhill side 2–3% for hiking trails and 5% for mountain biking trails to promote tread drainage (Minnesota DNR, 2007). However, all tread shapes constructed to shed water rarely maintain their constructed profiles over time: tread compaction, soil displacement from traffic, soil erosion, and the development of a berm along the lower trail edge soon act to keep water on the trail (Parker, 2004). Rocky tread substrates help to retain self-draining tread shapes over time but an appropriate density of grade reversals or the construction and maintenance of tread drainage features is additionally necessary.

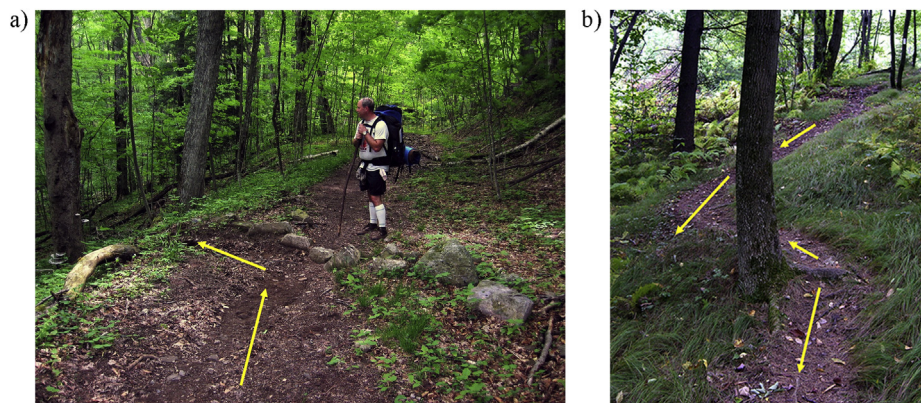
Fig. 3. a) This rock water bar is preceded by a ditch to drain water from the trail. b) Grade-reversals temporarily reverse the grade of the trail so that all water drains off; these rarely require maintenance. Photos by Jeff Marion.

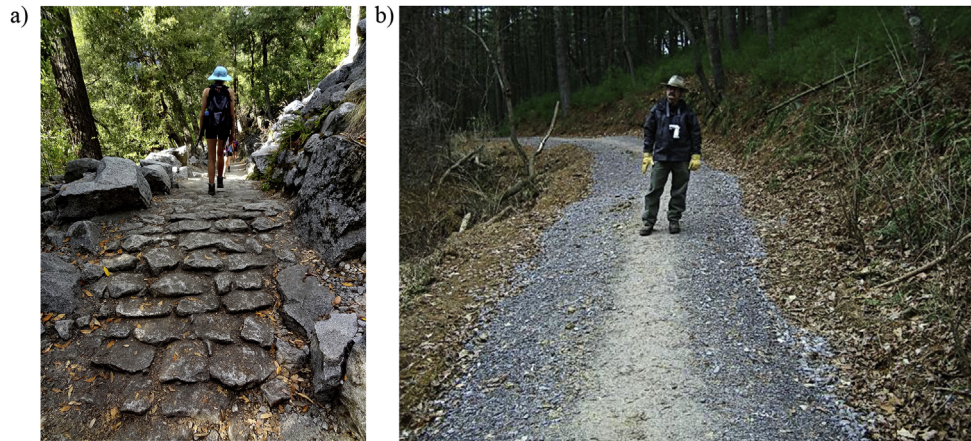
Fig. 4. a) Trails that must support heavy traffic, particularly by horses, can be armored with embedded rock (stone pitching). b) Crushed rock (gravel) also supports heavy traffic, though is more easily displaced when wet. Photos by Jeff Marion.

When trail design is constrained or insufficient to create a sustainable trail, managers can apply trail construction and maintenance practices, including application of stonework or gravel to harden trail treads (Fig. 4). Research has shown that trail substrates with a high rock or gravel content are less susceptible to soil erosion and better able to sustain heavy traffic, particularly by horses (Bryan, 1977; Weaver and Dale, 1978). A four-year study of primitive forest roads used for logging and recreation found that non-graveled roads lost 112 metric tons/ha/year of substrates while gravelled roads lost only 13.5 metric tons/ha/year (Kochenderfer and Helvey, 1987). Tread substrates with substantial rock and gravel content are also less easily displaced by recreational traffic, and these materials can act as filters, retaining and binding finer soil particles (Aust et al., 2004).

Various types of well-anchored rockwork, including tread armoring (stone pitching) and rock steps, are common tread hardening techniques used to deter erosion on steeper trail grades (Demrow and Salisbury, 1998; Footpath Trust, 1999) (Fig. 4a). This practice replaces erodible substrates with rockwork on wet or steeply graded trail segments particularly prone to erosion. No studies evaluating the long-term efficacy of employing rockwork to limit trail erosion could be found.

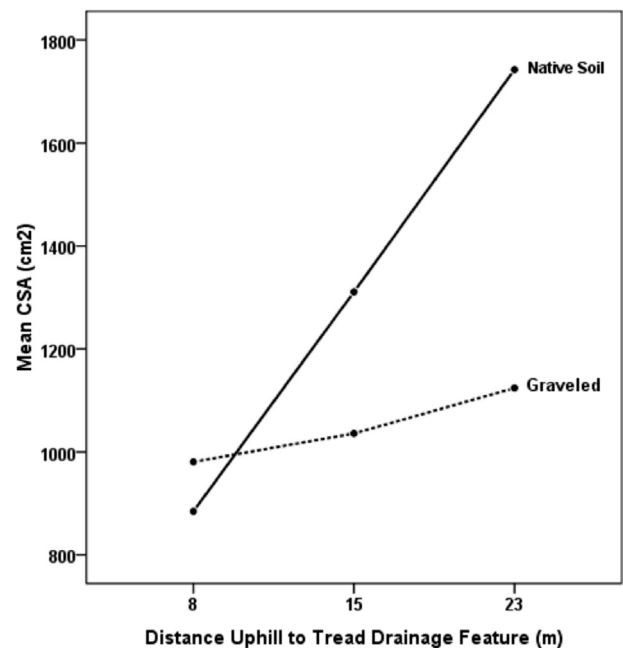
Fig. 6. Soil loss on HNF trails as influenced by graveling and proximity to tread drainage features.
